LER 2008-001-00- Manual Reactor SCRAM Due to Loss of Main Electrical

Output Transformer Cooling

Grand Gulf Nuclear Station, Unit 1

LER 2008-001-00

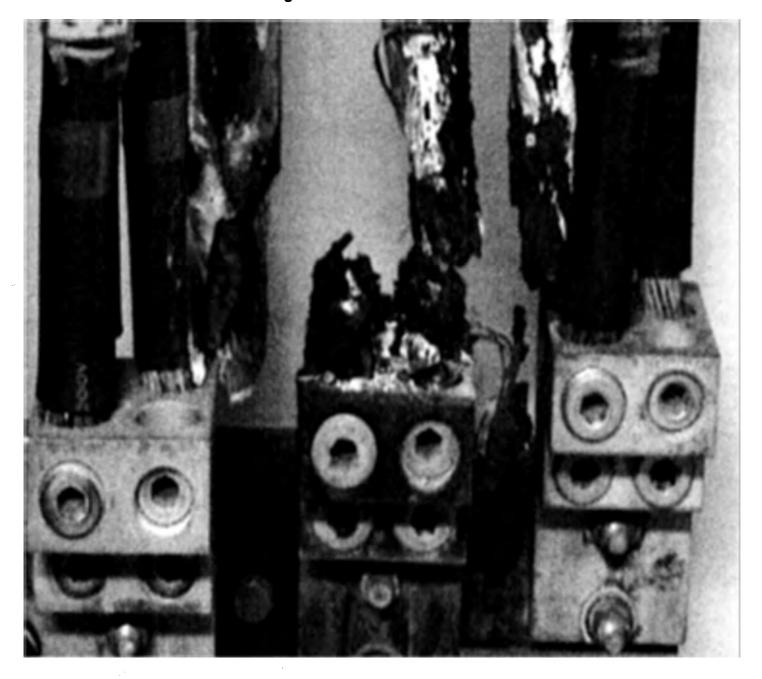
The cause of this event was the loss of cooling to the Main Transformers caused by loss of Auxiliary Power to the Main Transformer cooling system. Inspection of the complete circuit for Main Transformer Auxiliary Power showed that the "B" phase power cables were found to be burned in two at the transfer switch panel. The cause of the "B" phase power cable failure is attributed to failure of an electrical compression connection on a lug connection. This particular cable and connection has been inservice since plant start-up. Potential root causes were determined to be use of a compression connection for high current applications versus the preferred crimp type connection and an inadequate preventive maintenance strategy to provide early detection. Corrective actions included an inspection of the power panel and replacement of all damaged cabling.

The cause of this event was the loss of cooling to the Main Transformers caused by loss of Auxiliary power to the Main Transformer cooling system. Inspection of the complete circuit for Main Transformer Auxiliary Power showed that the "B" phase power cables were found to be burned in two in panel 1SMT1 (transfer switch panel). The cause of the "B" phase power cable failure is attributed to failure of an electrical compression connection on a lug connection; the connection was manufactured by BURNDY®, Model No. D1281. The root cause of the power cable failure could not be conclusively determined by the initial investigation. This particular cable and connection has been inservice since plant start-up. One potential root cause was determined to be use of a compression connection for high current applications versus the preferred crimp type connection. Another potential root cause was there was an inadequate preventive maintenance strategy to provide early detection. Figure 1 provides a picture of the failed connection.

Figure 1 – As Found Condition

Immediate Corrective Actions – Completed inspection of the 1SMT1 Transfer Switch Panel. All damaged cabling has been replaced. Inspection results indicate that no damage occurred to the affected transformers and all equipment responses were as designed and expected.
